# Turramurra House

**Turramurra, NSW, Australia**  
Cullinan Ivanov Partnership  
Photography: Charmaine Pang

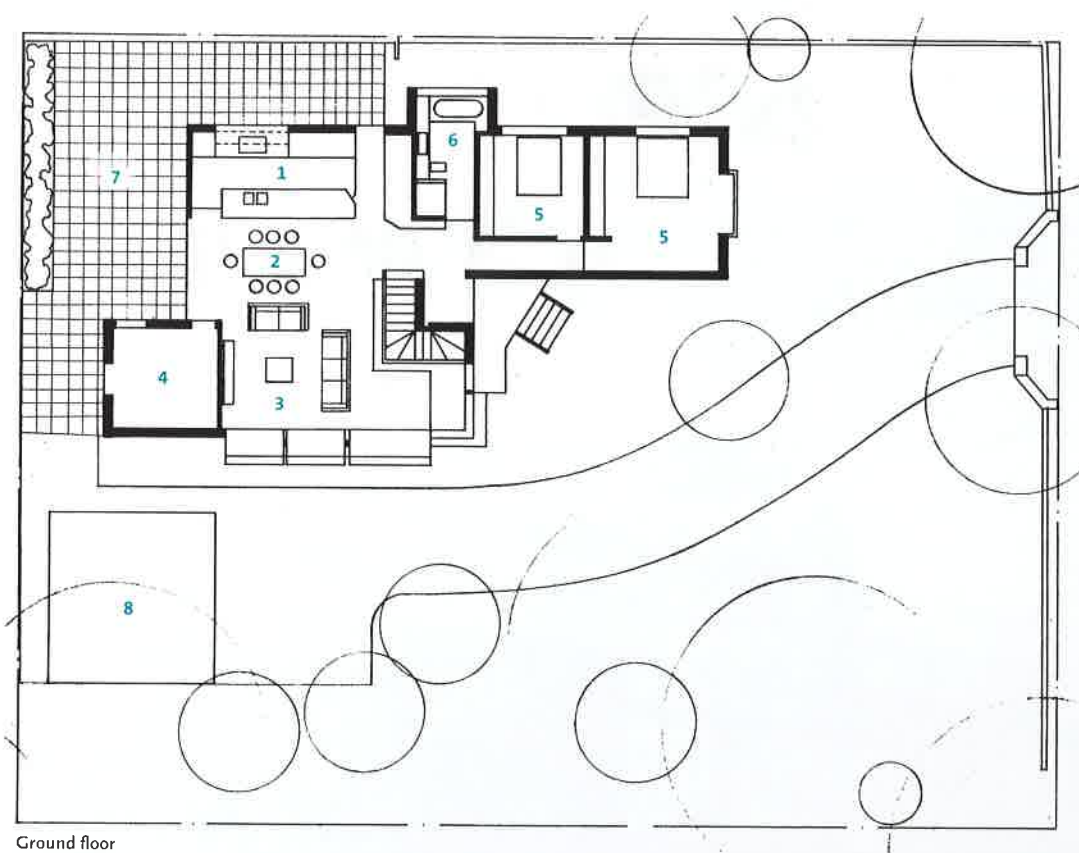
Ground floor

- 1 Kitchen
- 2 Dining room
- 3 Living room
- 4 Study
- 5 Bedroom
- 6 Bathroom
- 7 Deck
- 8 Garage
